SPOTLIGHT ON

KING GEORGE DOCKS

QUAYSIDE STRENGTHENING AND REPAIRS

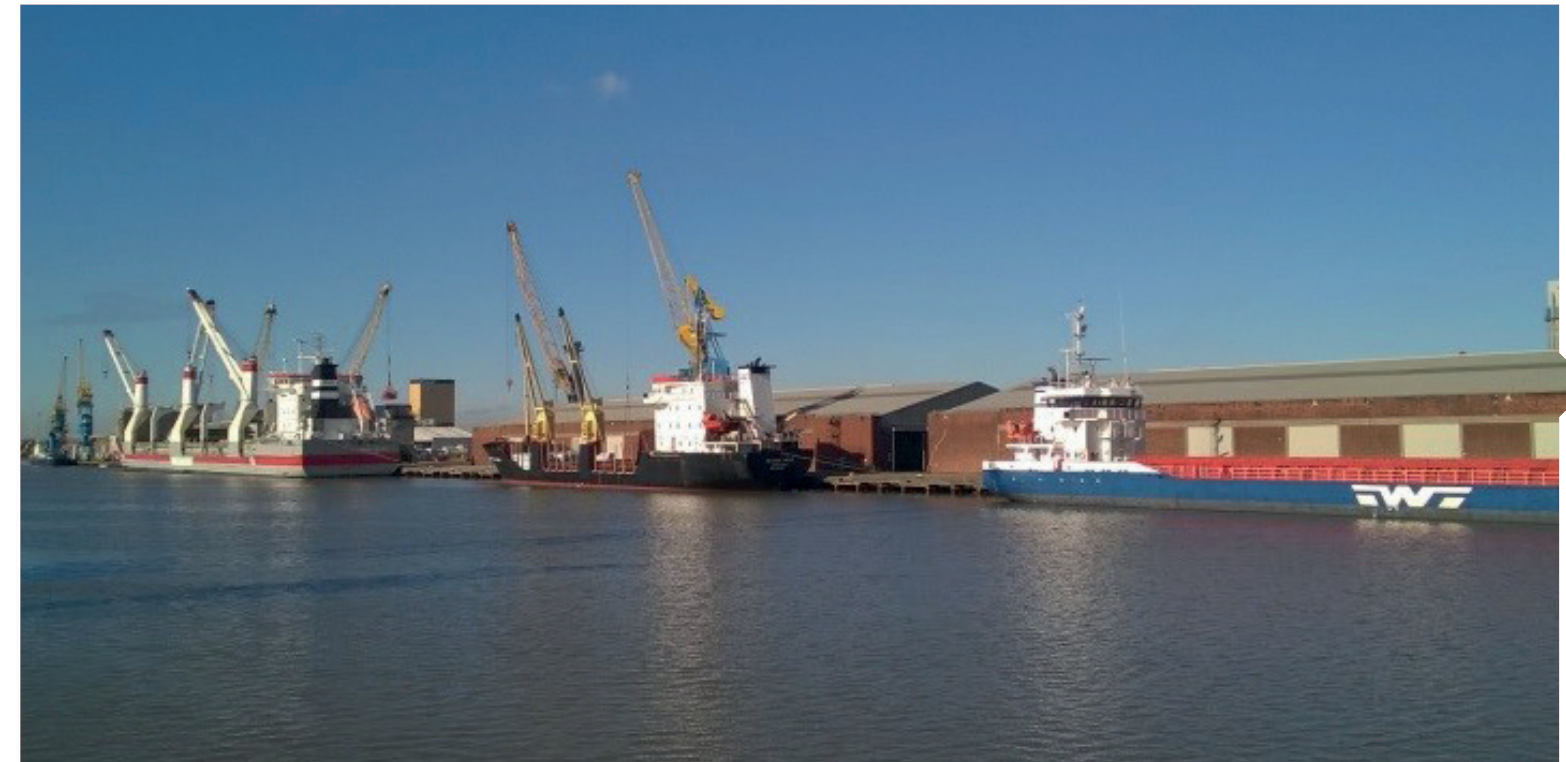
QUAYSIDE STRENGTHENING AND REPAIR WORKS AT KING GEORGE DOCKS, HULL.
