Tintern Wireworks Bridge

VolkerLaser was contracted by Gloucestershire County Council to undertake strengthening and refurbishment to the Tintern Wireworks Bridge.

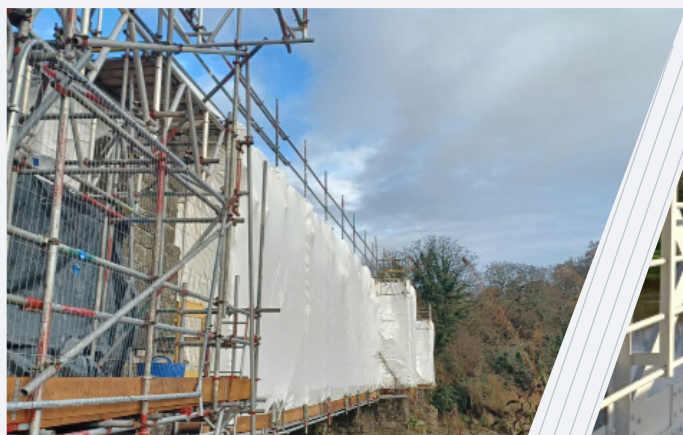
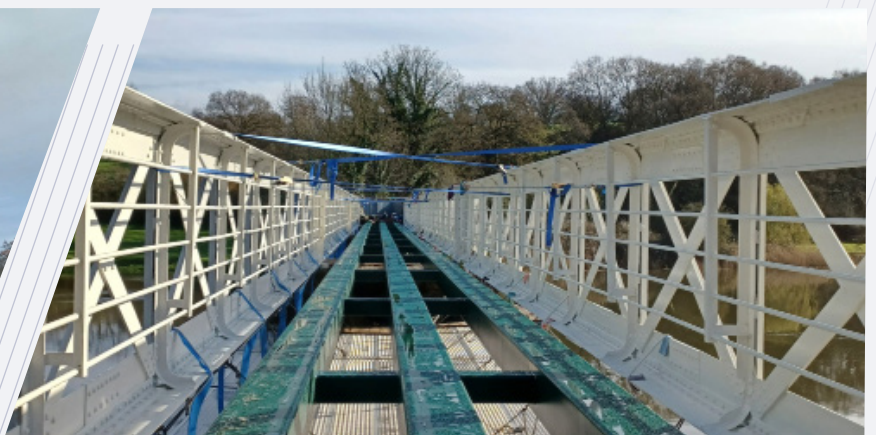
To facilitate the installation of the new deck, temporary cross-beams with a roller and guide arrangement were set up, spanning between the bottom flanges of the existing bridge beams. The beams, rollers and guides are referred to as a 'launching system' and allowed the beams to be pushed across the span of the existing bridge and into position.

The team used a 40t crane to lift the new steelwork onto the launching system. The site team pushed each of the five beam sections into position by hand and the first centre string was installed in approximately four hours. The beam string was then checked for alignment and jacked up to the correct level, ready for welding. Following the installation of the first string, the outer strings were delivered and installed over a weeklong period and were fully welded together to create the new deck structure.
