# KING GEORGE DOCKS

QUAYSIDE STRENGTHENING AND REPAIRS

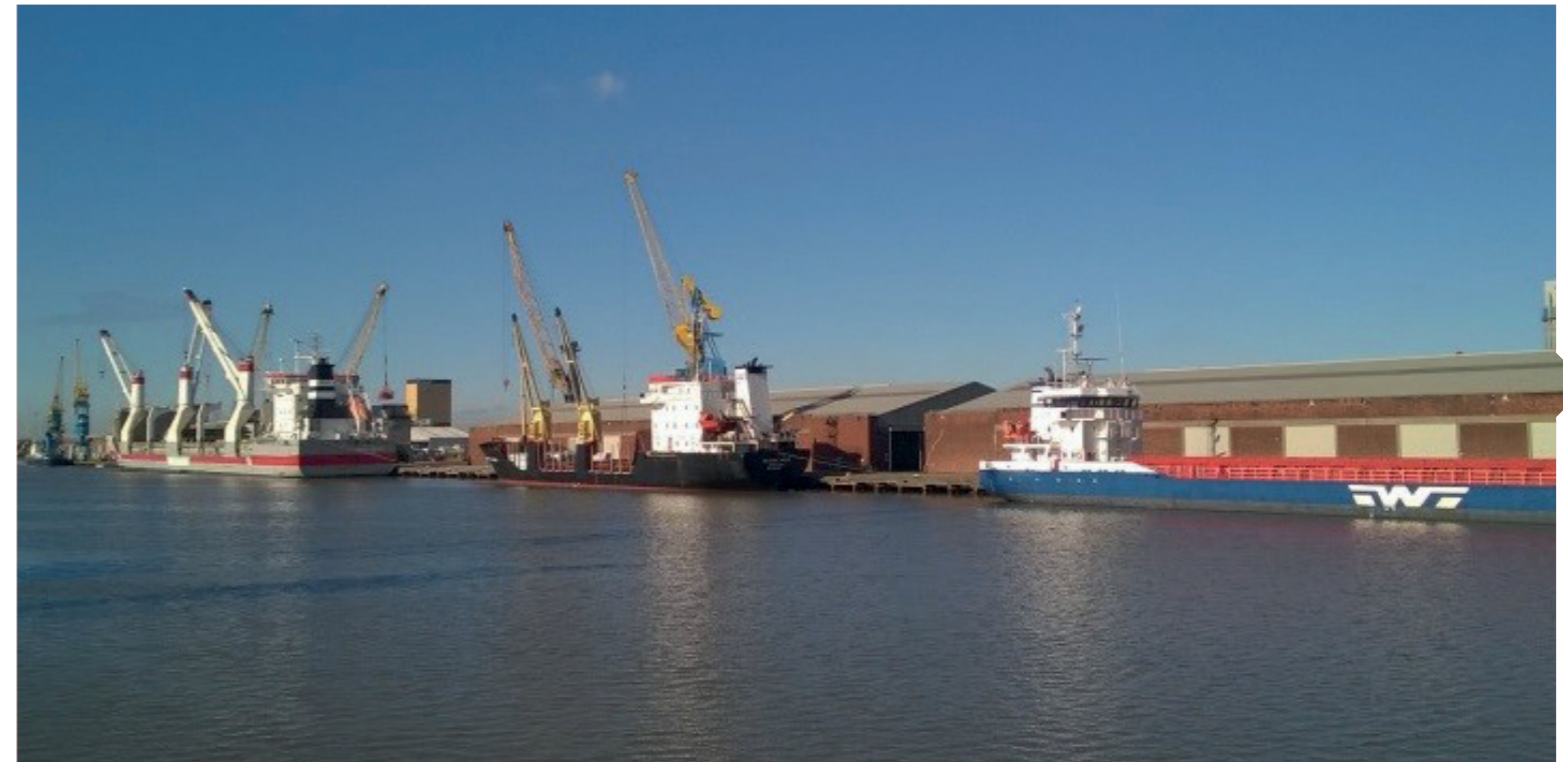
**QUAYSIDE STRENGTHENING AND REPAIR WORKS AT KING GEORGE DOCKS, HULL.**

With safe access obtained, the first major element of the works could be undertaken. High pressured water jets were employed in the hydrodemolition of existing delaminated concrete on the quayside beams and columns. Subsequently, any exposed link reinforcement bars (rebars), which were shown to be corroded or damaged, were replaced to reinstate the substructure strength. Approximately 10,800 galvanic anodes were then attached to the new and existing link rebars, in order to prevent any further corrosion.

The beams and columns were re-profiled with timber formwork, acting as a mould structure in readiness for the concrete repairs.

Approximately 370m<sup>3</sup> of Sika 133F spray applied concrete was utilised in order to achieve a superior level of structural integrity.

For the crane beams, where the structure was compromised, extensively due to the corrosion of the rebars, additional strengthening was required. VolkerLaser collaborated with design engineers Curtins, in developing a unique and innovative solution of applying carbon fibre Sika wrap to restore integrity to the beams. King George Docks marks the very first time carbon fibre wrapping has been successfully utilised for structural strengthening within a marine environment.
