SPOTLIGHT ON

# M5 OLDBURY VIADUCT

CONCRETE REPAIR AND WATERPROOFING

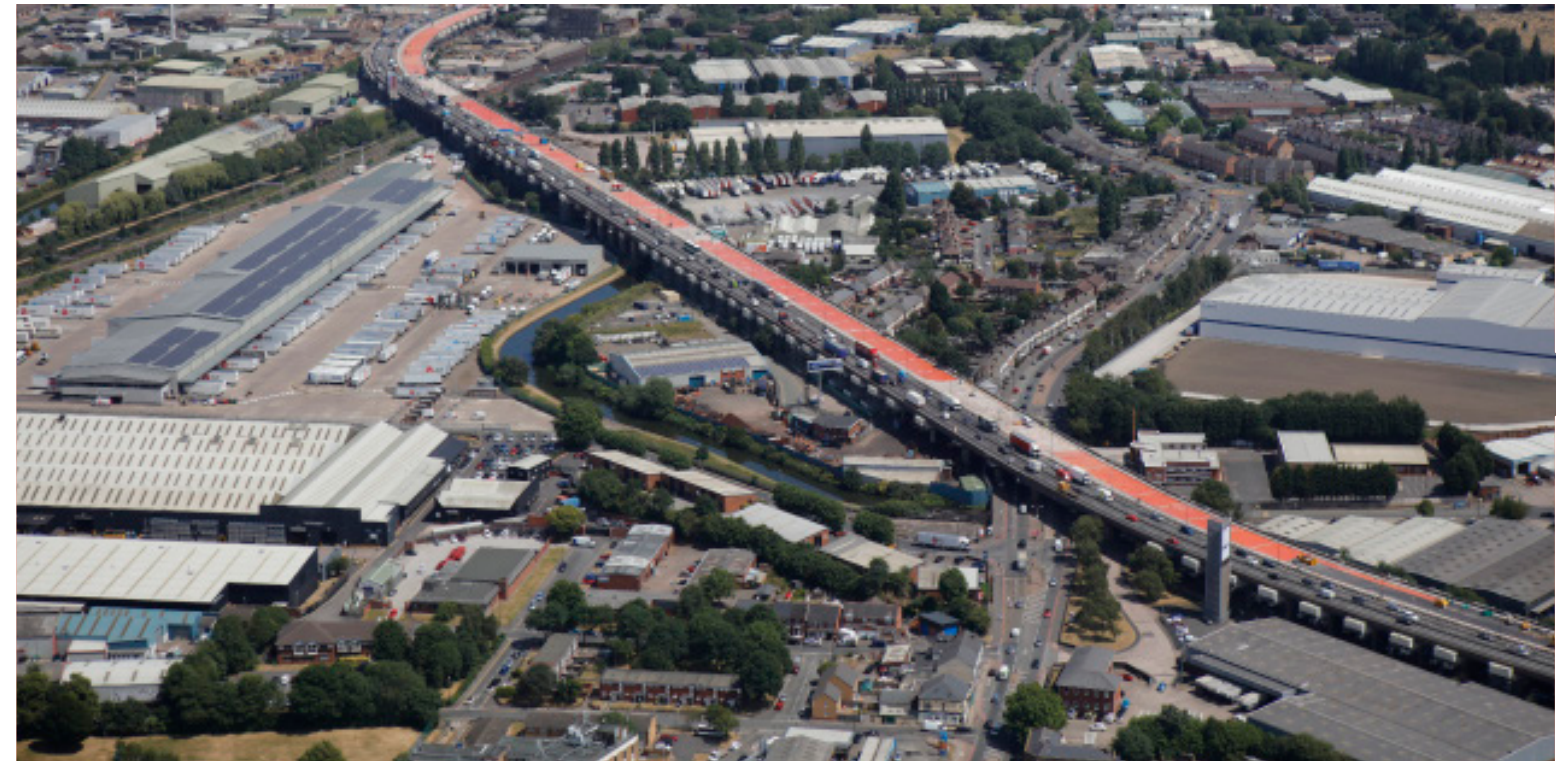
**i** THE M5 OLDBURY VIADUCT BETWEEN JUNCTIONS 1 AND 2 - CONCRETE REPAIRS AND WATERPROOFING.
