SPOTLIGHT ON

M5 OLDBURY VIADUCT

CONCRETE REPAIR AND WATERPROOFING

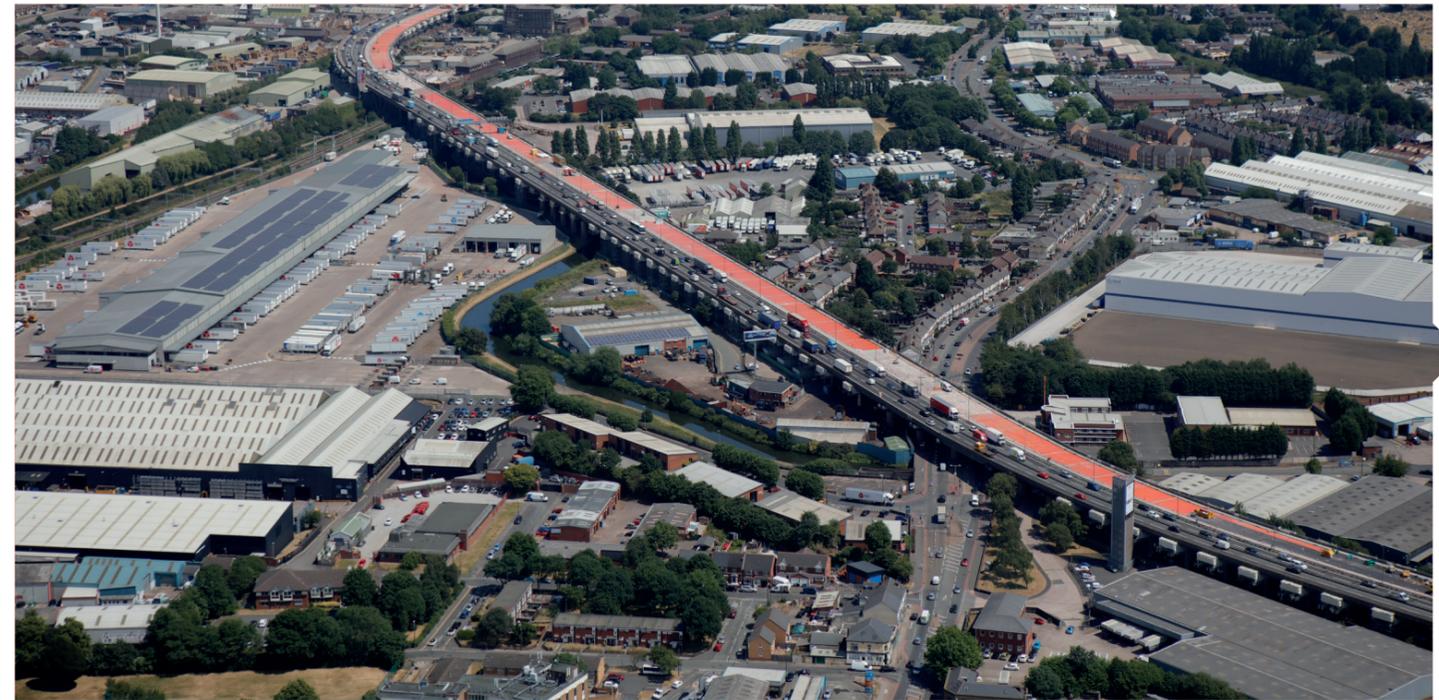
i THE M5 OLDBURY VIADUCT BETWEEN JUNCTIONS 1 AND 2 - CONCRETE REPAIRS AND WATERPROOFING.
