## Cleethorpes Road Overbridge

Opening in 1968, Cleethorpes Road Overbridge comprises 17 twin concrete spans supported on concrete piers. During an initial inspection undertaken, considerable decay and dilapidation to the bridge was discovered, particularly to its elastomeric bridge bearings.

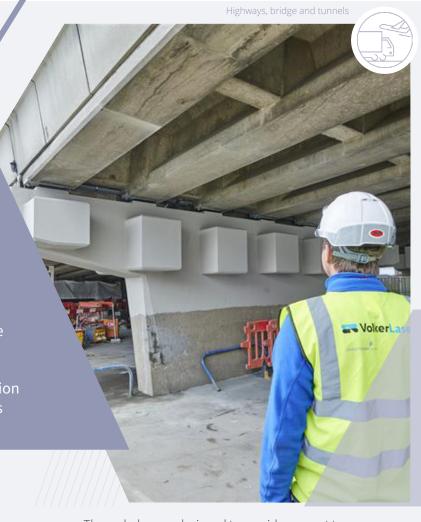
As an alternative solution that enabled a competitive tender submission, our expert team proposed constructing reinforced concrete corbels, stitched to the existing piers, to serve as jacking points for the bridge.

The corbels were designed to provide support to the jacking system to lift the deck during the bearing replacement operation, thus eliminating the need for any works at ground level.
